DECISION DOCUMENTATION PACKAGE
COVER SHEET

SITE DESCRIPTION: CONTAMINATED SOIL IN TANK FARM AREA NEAR VALVE
Box B-9

SITE ID: CPP-30

OPERABLE UNIT: 3-07

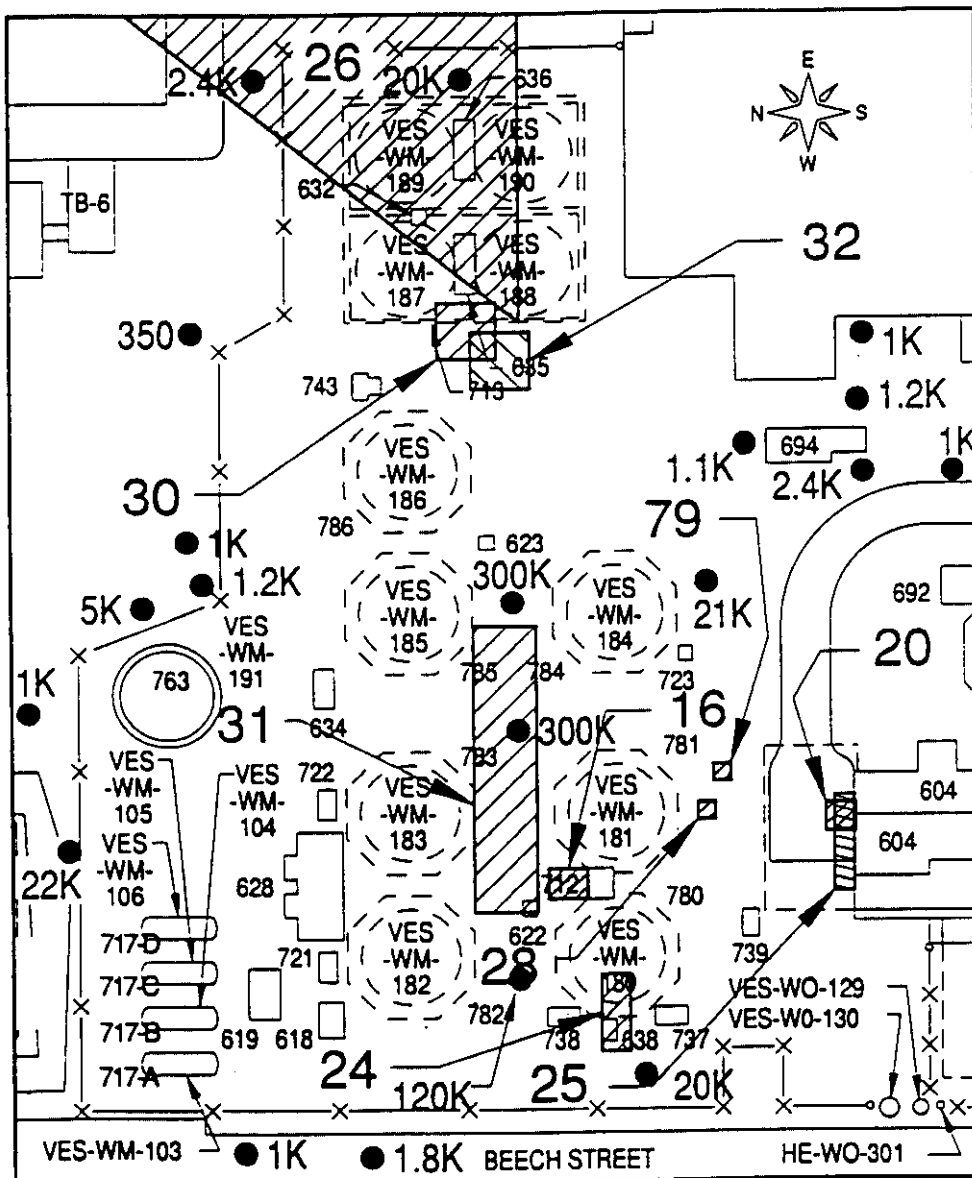
Site Locations within OU 3-07 with Rad Points

Also, the results of the surface radiation surveys conducted in 1990 and 1991 (ref. 3, 5) do not indicate the presence of radiation levels above background at this site.
